Manawa Mill Pond Dam Replacement Feasibility Analysis

Replacement Feasibility Analysis

May 28, 2025

Engineer's Project Number: 4921-0052

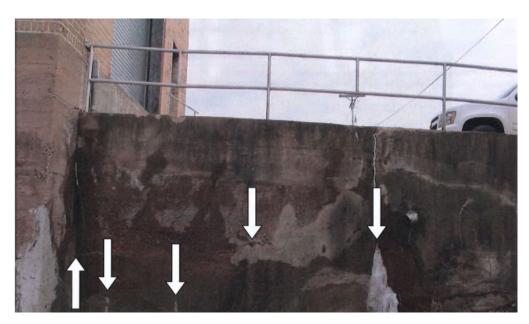
Figure 2-1

An inspection of the dam was completed in 2010 and 2011. Several deficiencies were identified including cavitated spillways, deteriorated piers, a seven square foot cavity in the downstream training wall, a 17 square foot void in a retaining wall and audible seepage flowing underneath an apron. Some immediate repairs were completed in 2011 however a drawdown of the impoundment was needed for the remainder of the repairs. Phase 2 of the repairs were made to the dam in 2012. In 2016, it was noted that there were slight leaks to the left retaining wall (Figure 2-1). It is not known whether the cracks were repaired or it was recommended to monitor.

Retaining Wall Cracks (March 7, 2016)

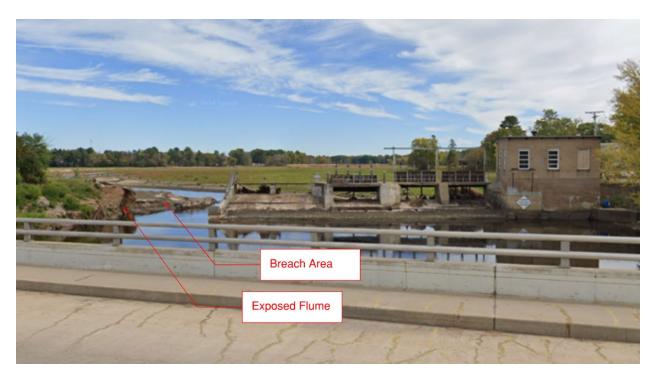
The earthen berm (embankment) was overtopped on July 5, 2024. An inspection report indicated that the earthen berm overtopped once before in 1970 with no damage. The recent breach washed out the earthen berm and exposed two parallel concrete walls. The southern wall partially collapsed but did not fall into the river. A plan from 1920 identifies the grist mill as being on the north side of the river. The concrete walls appear to be a previously abandoned concrete flume to the grist mill. The following figure documents the status of the dam following the breach.

Figure 2-3
Streetview Photo Post-Breach, October 2024

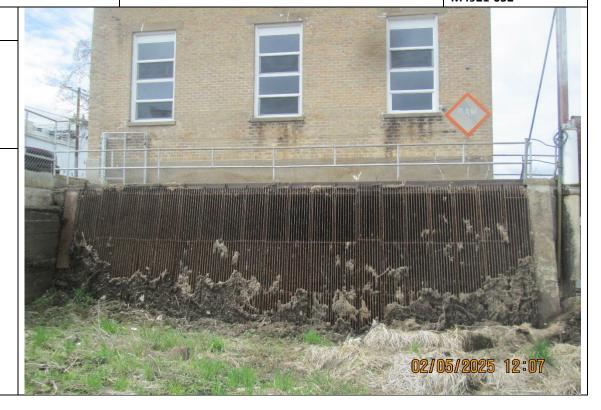
Inlet at powerhouse

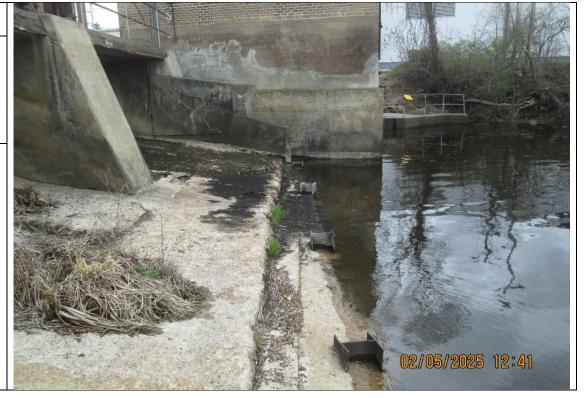
Photo No. Date: 2 5-2-25

Right side of powerhouse

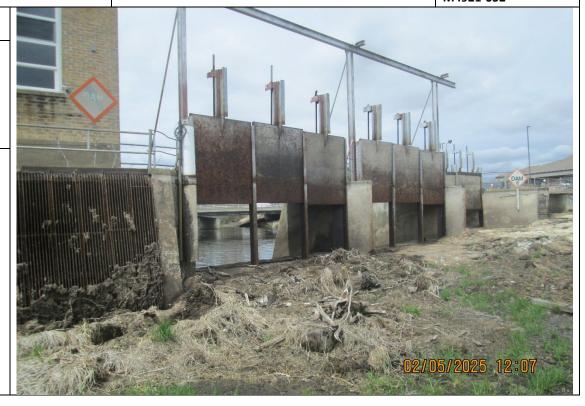
Bay 1 & 2 Upstream

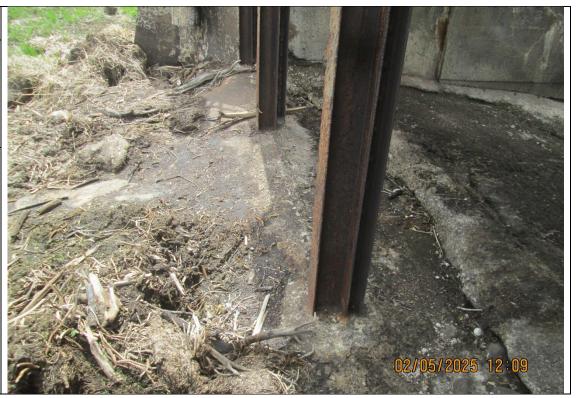
These bays have three sluice gates each that are 6-foot wide by 7.5-feet high. To the left side of Bay 1 is the powerhouse; Bays 1 and 2 are separated by a 3-foot-wide concrete pier. The concrete at the base of the gates in both bays is deteriorated with concrete spalling present. The downstream apron of the bays is spalling and cracking. The underside of the concrete walkway exhibits spalling with exposed reinforcement. The left abutment of Bay 1 shows diagonal cracking with efflorescence.

Bay 1 Concrete condition at sluice gates

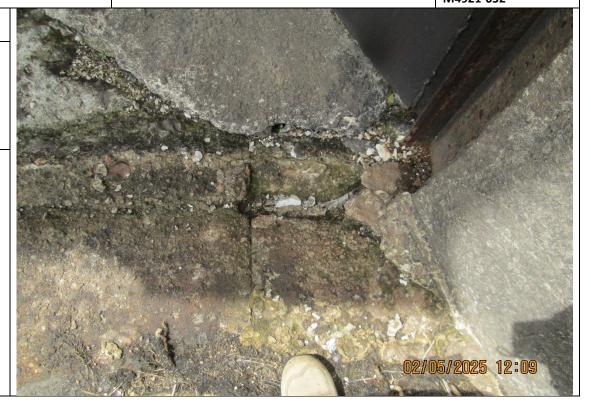
Bay 1 Concrete condition at sluice gates

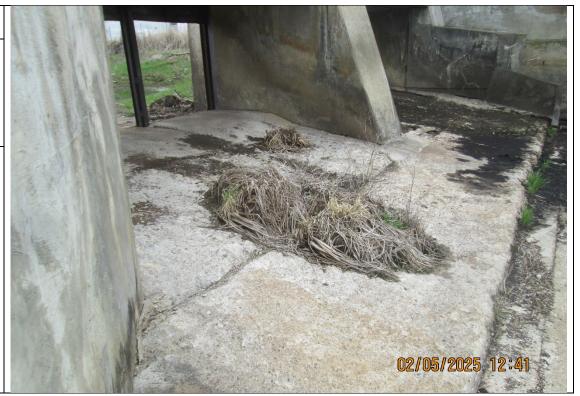
Photo No. Date: 6 5-2-25

The spillway of the dam is showing spalling and cracking throughout. The concrete below the gates is uneven and will not provide a good seal.

Bay 1 & 2 spillway concrete deterioration

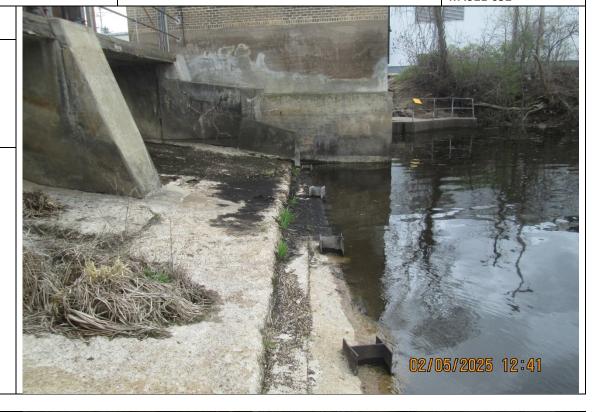
Bay 1 & 2 spillway concrete deterioration

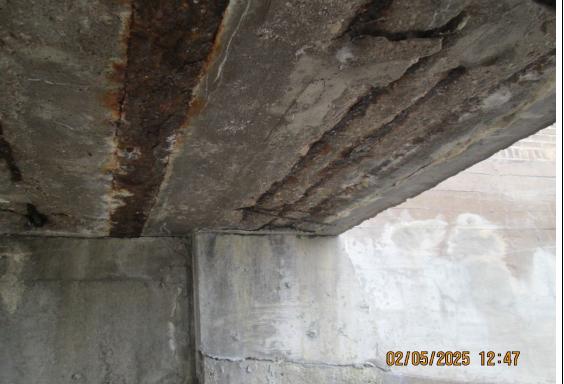
Photo No. Date: 8 5-2-25

The dam is showing significant concrete deterioration. The concrete walkway is also showing significant spalling and has exposed reinforcement from Bays 1 through 3. In Bays 4 and 5 the concrete walkway is noticeably sagged. The gates in Bays 1 through 3 utilize the walkway as a support for gate operation. Bays 4 and 5 also utilize the walkway for the upper support for the needle boards. The inspection indicates that the walkway would need to be replaced in its entirety. Repairing does not appear to be feasible. Since the gates utilize the walkway for support, the gate mechanisms will also need to be replaced.

Underside of walkway at bay

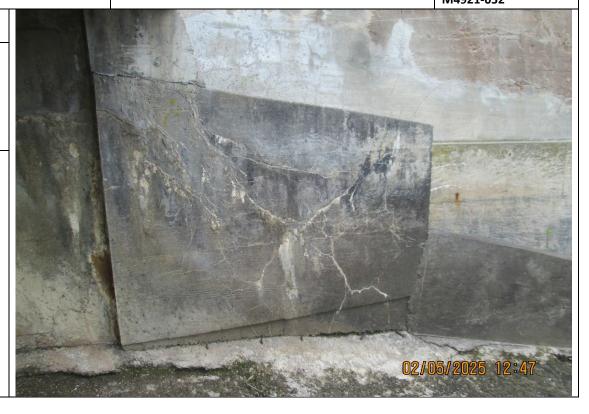
Left abutment at bay 1

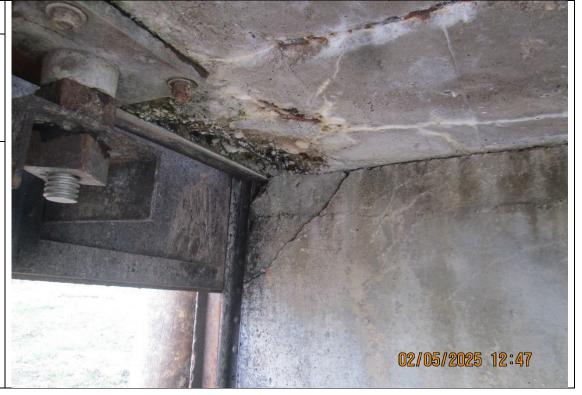
Photo No. Date: 10 5-2-25

Lt abutment and walkway at bay 1. deterioration

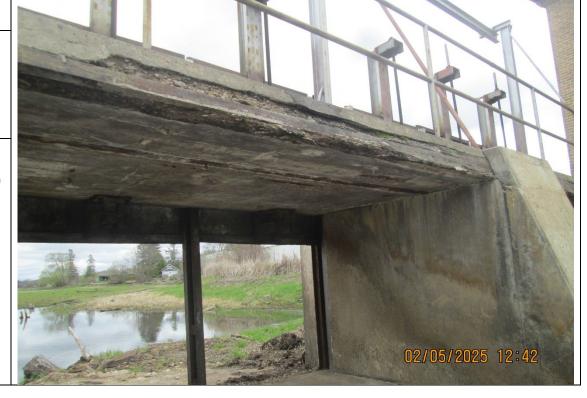
Bay 2 walkway deterioration

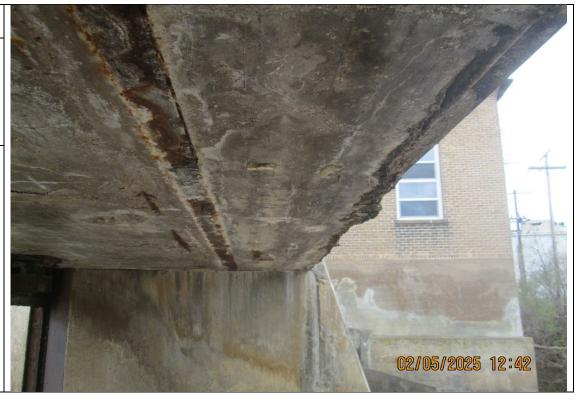
Photo No. Date: 12 5-2-25

Bay 2 walkway deterioration

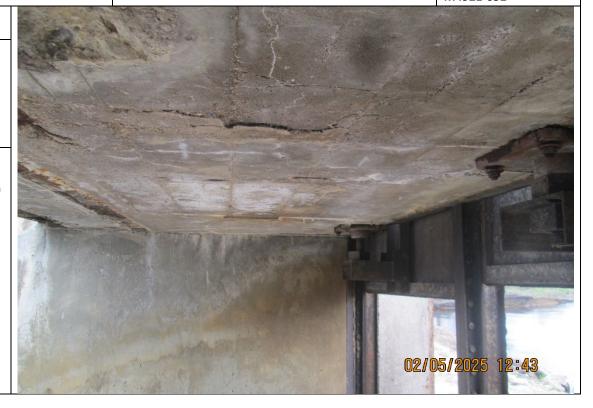
Bay 3 walkway deterioration

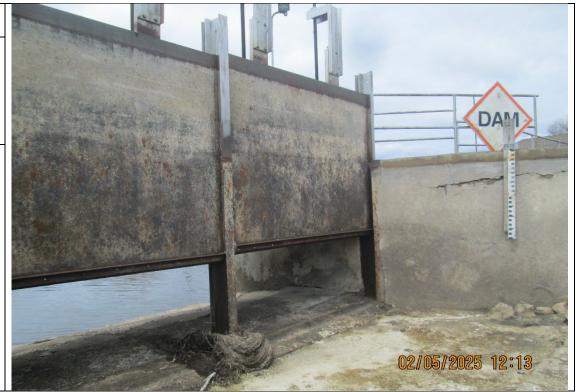
Photo No. Date: 14 5-2-25

Bay 3 sluice gates - upstream

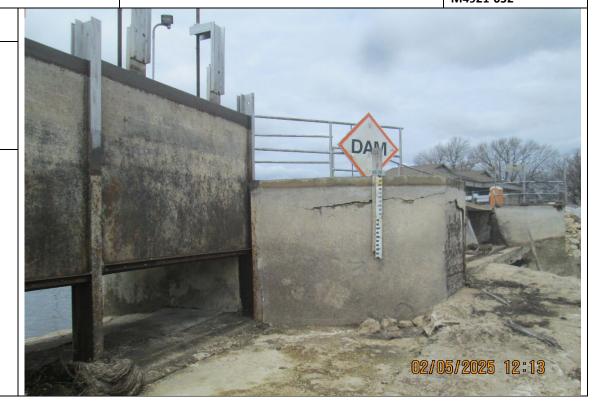
This bay consists of two 10-foot wide by 7.5-foot-high sluice gates. The left concrete pier is approximately 7-foot wide at the upstream side; the right concrete pier is approximately 3.5-foot wide at the upstream side. The concrete at the base of the gates is spalling and cracked. The upstream base consists of stone with a thin concrete overlay. This stone and concrete overlay is deteriorated and cracked. The underside of the concrete walkway is showing severe spalling with exposed reinforcement. The downstream edge of the walkway is also severely spalled. The left concrete pier has a large vertical crack. The apron is also cracked and spalled.

Right pier of bay 3 deterioration.

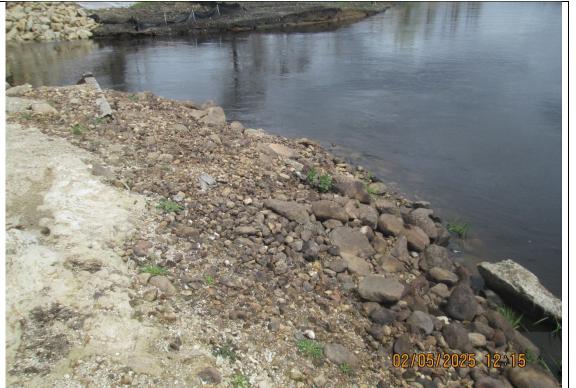
Photo No. Date: 16 5-2-25

Upstream condition of bay 3

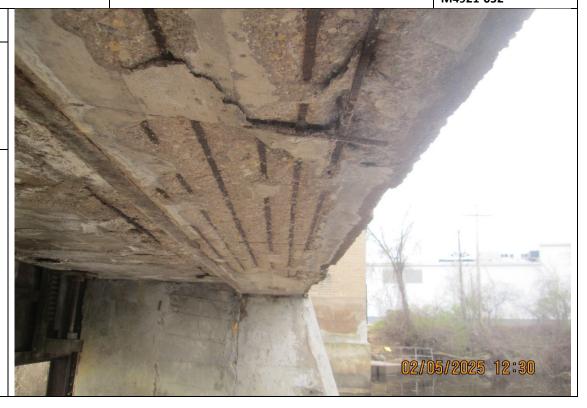
Below walkway of bay 3. Concrete deterioration and exposed reinforcement

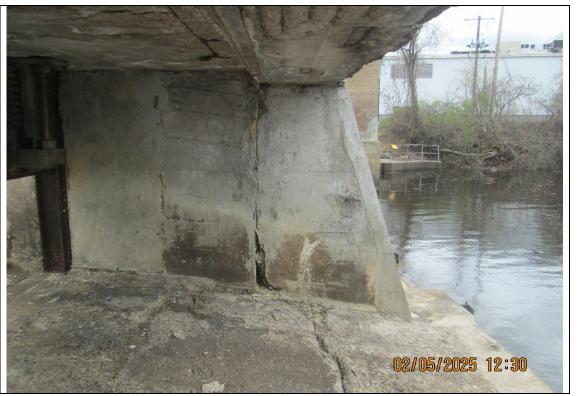
Photo No. Date: 18 5-2-25

Apron and left pier deterioration of bay 3

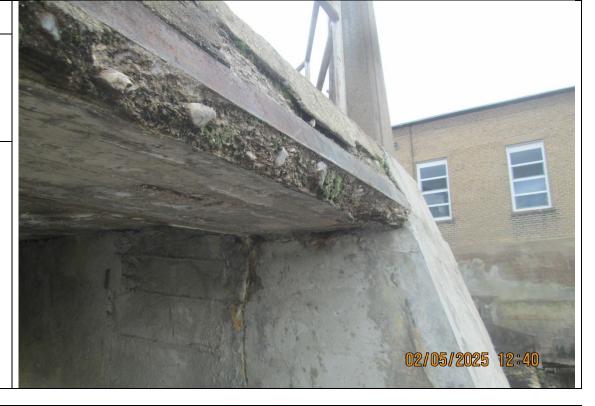
Downstream walkway deterioration bay 3

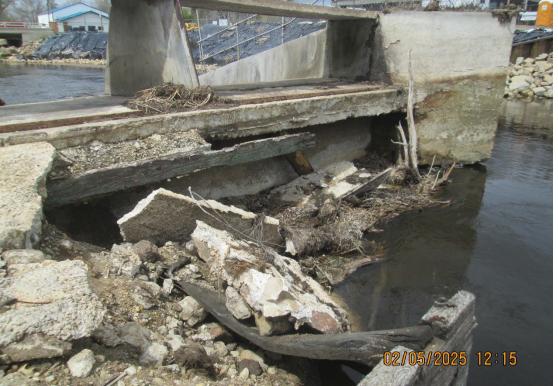
As a result of the July 2024 breach, the foundation of the dam has been severely compromised. This is most evident in Bays 4 and 5 where the timber cribbing and rock foundation are visible. A portion of the timber cribbing and rock foundation was washed out under Bay 5 and severely compromised in Bay 4.

Upstream condition at bays 4 and 5. Section is undermined. Timber cribbing and rock fill have been washed away.

Given the severity of the foundation condition in Bays 4 and 5, complete reconstruction of these bays would be required including a new foundation. Repairing this section of the dam is not feasible. The foundation condition of Bays 1 thru 3 would require further investigation to determine what repairs would be required. Previous history would indicate that grout injections would most likely be required to prevent seepage below the dam.

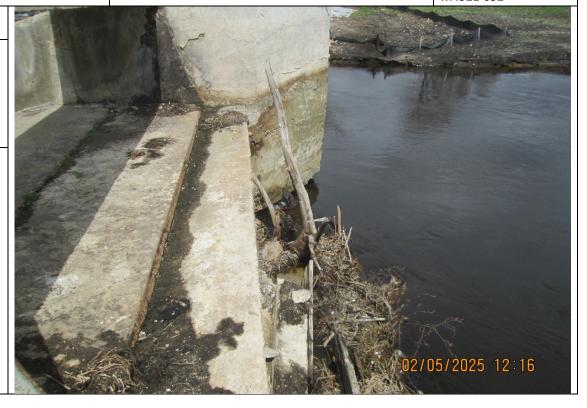
Right abutment of bay 5 is undermined.

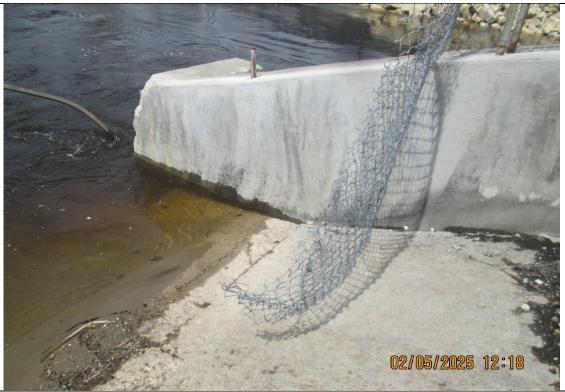
Photo No. Date: 22 5-2-25

Right abutment of bay 5 is undermined and leaking between apron and abutment.

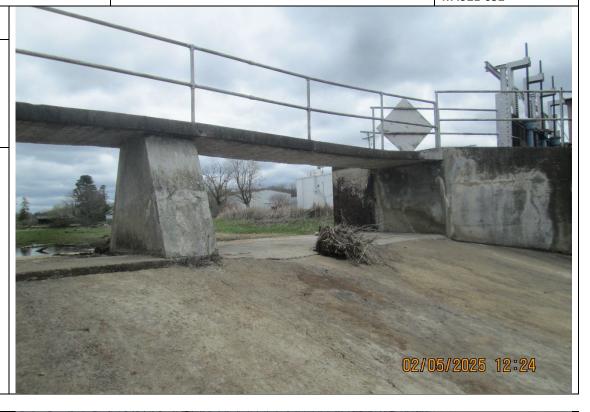
Walkway over bays 4 and 5 is sagging

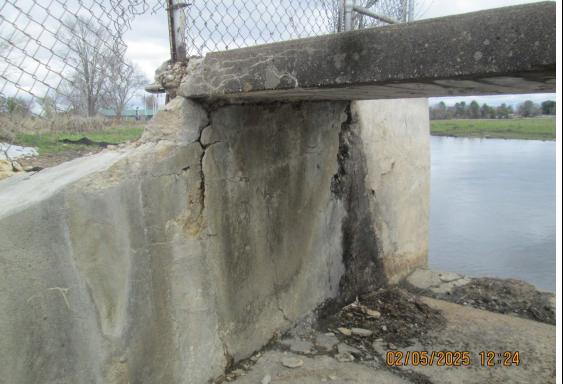
Photo No. Date: 24 5-2-25

The piers are in fair condition but would require significant concrete repairs. The left abutment would require a more thorough inspection with the powerhouse but appears that it would require crack repairs. The intermediate piers are showing cracking and spalling that would require repairs. The right abutment of Bay 5 is undermined and is showing water leakage between the pier and downstream apron. The right abutment is also severely cracked and spalled at the walkway support.

Concrete deterioration of the right abutment of bay 5 at walkway

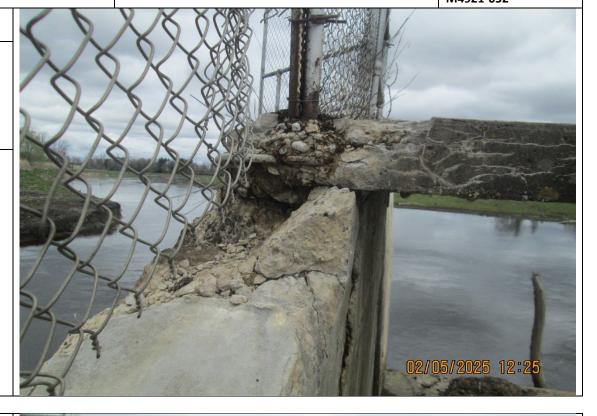
Concrete deterioration of the right abutment of bay 5 at walkway

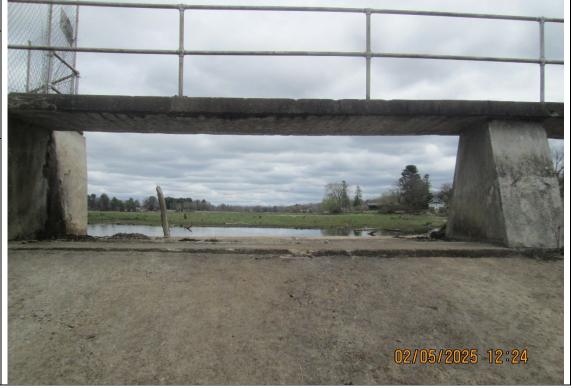
Photo No. Date: 26 5-2-25

Sagging walkway between pier and right abutment of bay 5

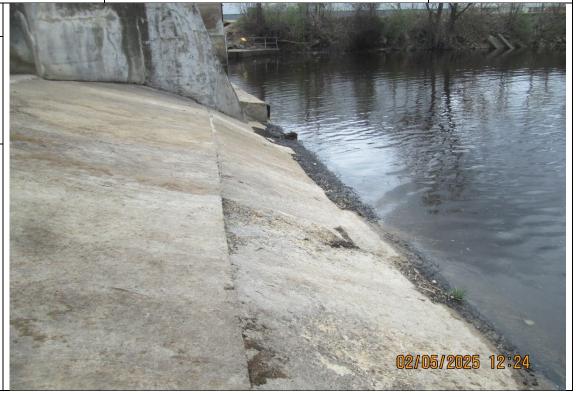
These bays consist of two 16-foot wide by 4.2-feet high needle board spillway sections. Bay 4 and Bay 5 are separated by a 2-foot-wide concrete pier. The right concrete abutment is approximately 2-feet wide and formerly abutted the earthen berm. The upstream side of these bays show a major loss of material from behind and below the concrete apron. There is leaking and separation between the apron and right abutment. The concrete walkway over these bays is noticeably sagging. Where the walkway intersects the right abutment, there are serious vertical cracks and significant spalling. The downstream apron is also cracked and spalled throughout.

Bay 4 and 5 apron condition
