# **City of Manawa Manawa Mill Pond Dam Replacement Feasibility Analysis Summary**

May 28, 2025

# Structural Assessment

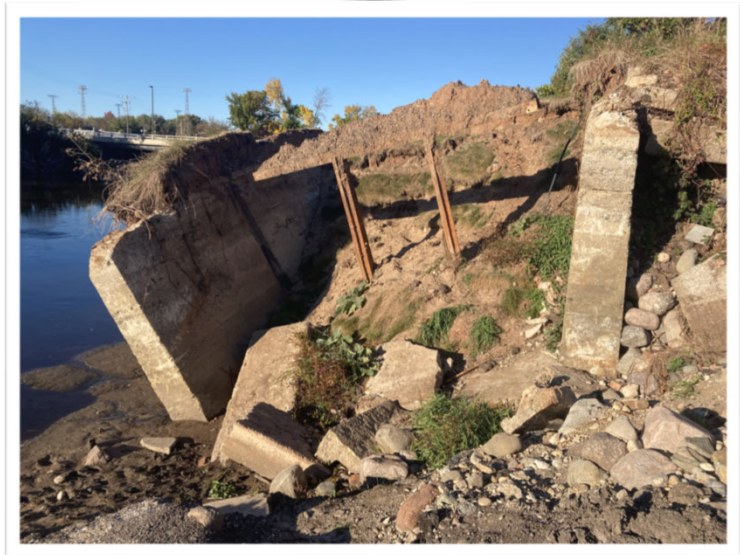
# 1920 Plans

- **First authorized by the State in 1891**
  - “maintain”
  - Likely constructed prior to 1891
- **Around 1915, Dam was used for private power generation**
  - Inspection reports at that time indicate the dam was reconstructed several times with the concrete added around 1913
- **1920 Plans show the Planning and Grist Mill**

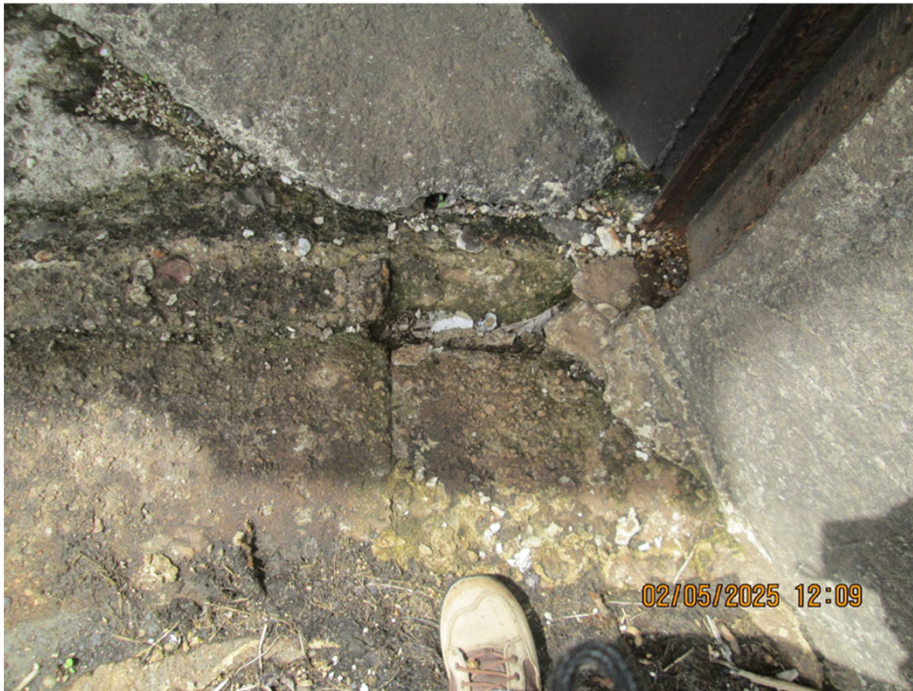
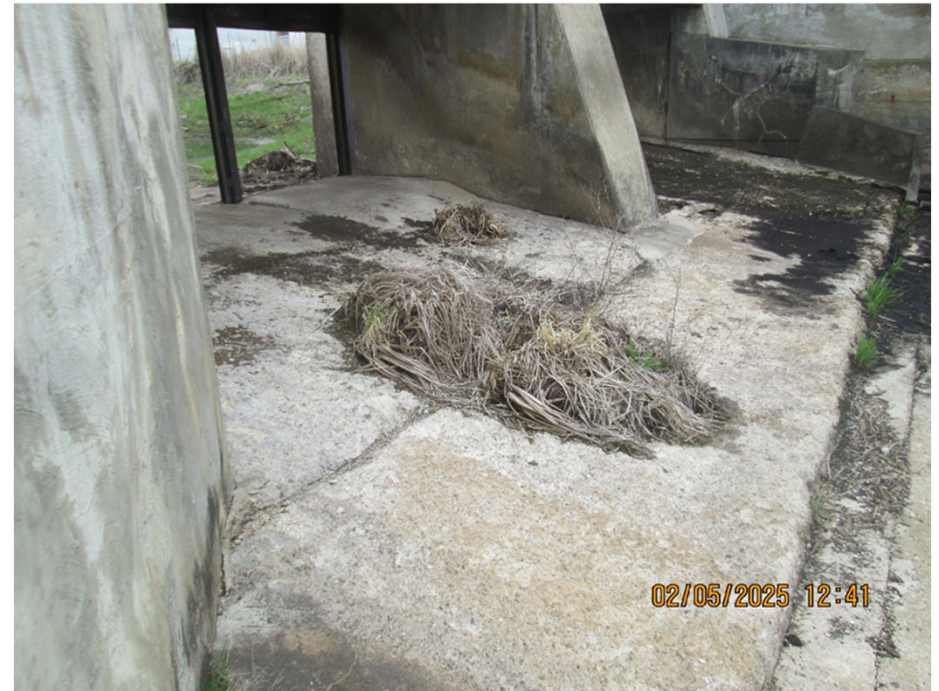
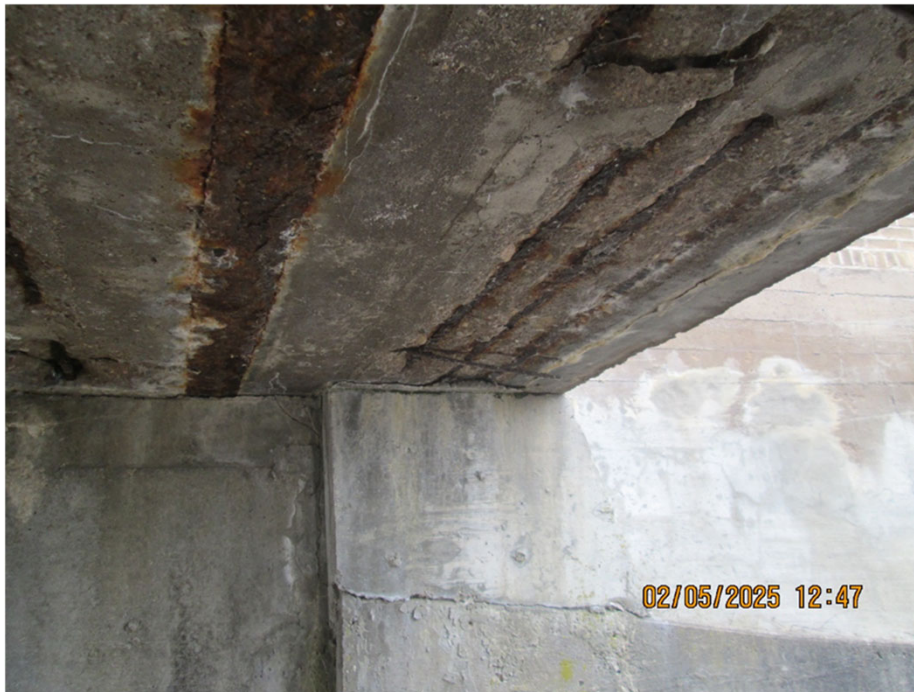
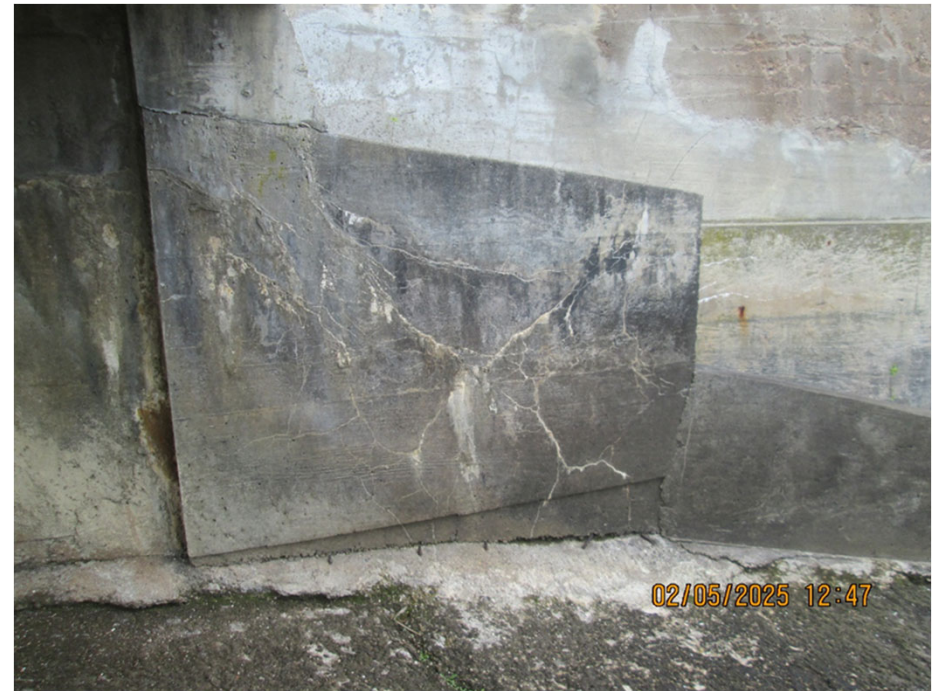
- Bay 1 and Bay 2

- **Bay 1 and Bay 2**
  - **Deteriorated concrete present at the gates**
  - **Downstream apron is spalling and cracking**
  - **Underside of walkway:  
concrete is spalling and reinforcement is exposed**
  - **Efflorescence observed at cracks in powerhouse wall**

- **Due to the condition of the existing Dam and the history of the previous repair work to the foundation, repair of the Dam is not feasible, and a complete replacement is recommended.**

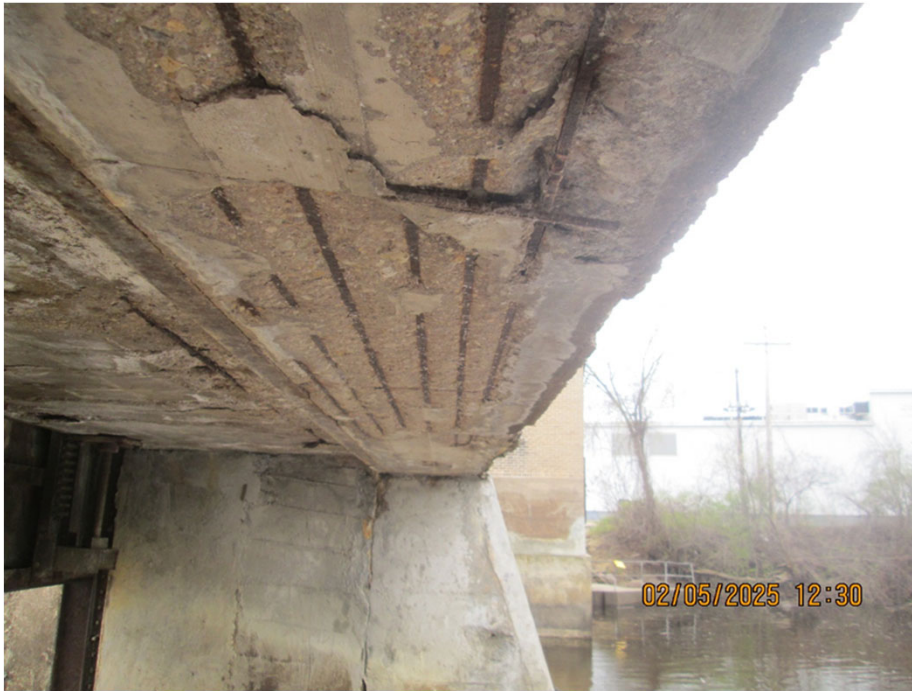
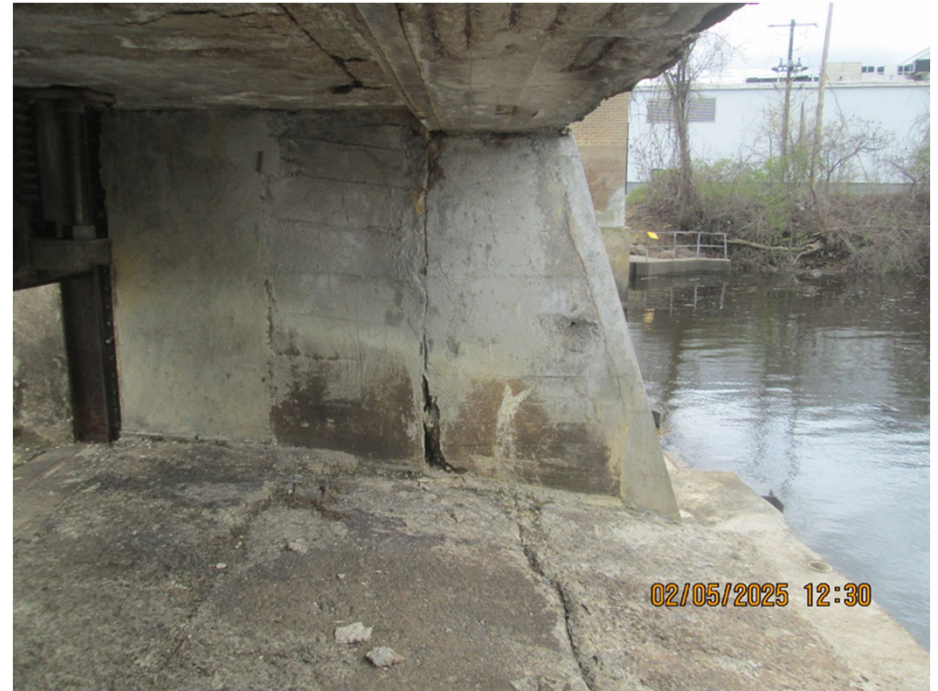
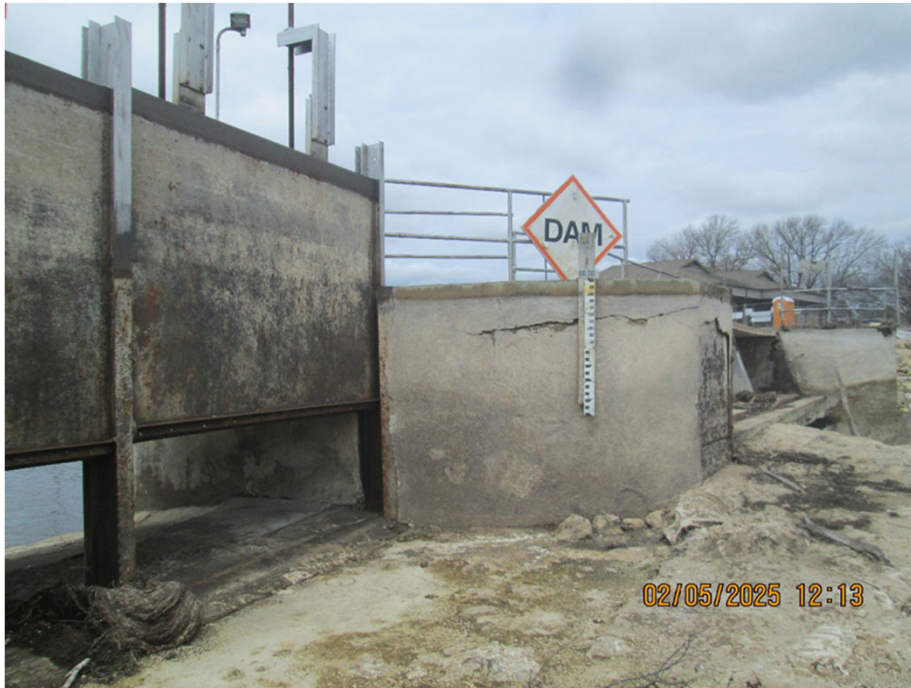
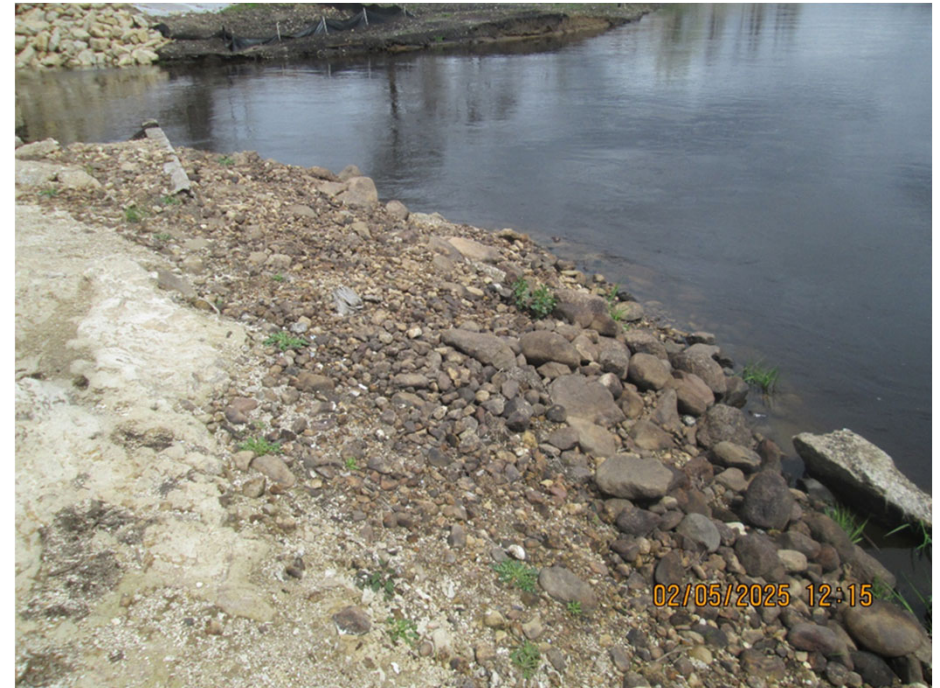
- Bay 3

- **Bay 3**
  - **Spalling and cracked concrete at the gates**
  - **Upstream base is the timber and stone cribbing with concrete or grout overlay. The stone and concrete overlay is deteriorated and cracked.**
  - **Underside of walkway:  
concrete has severe spalling and reinforcement is exposed**

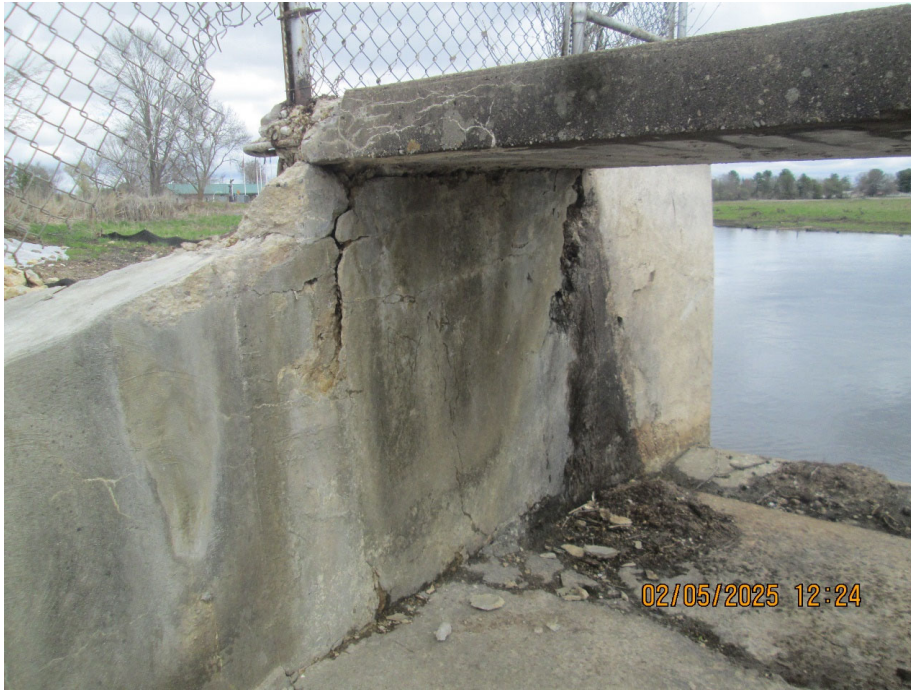
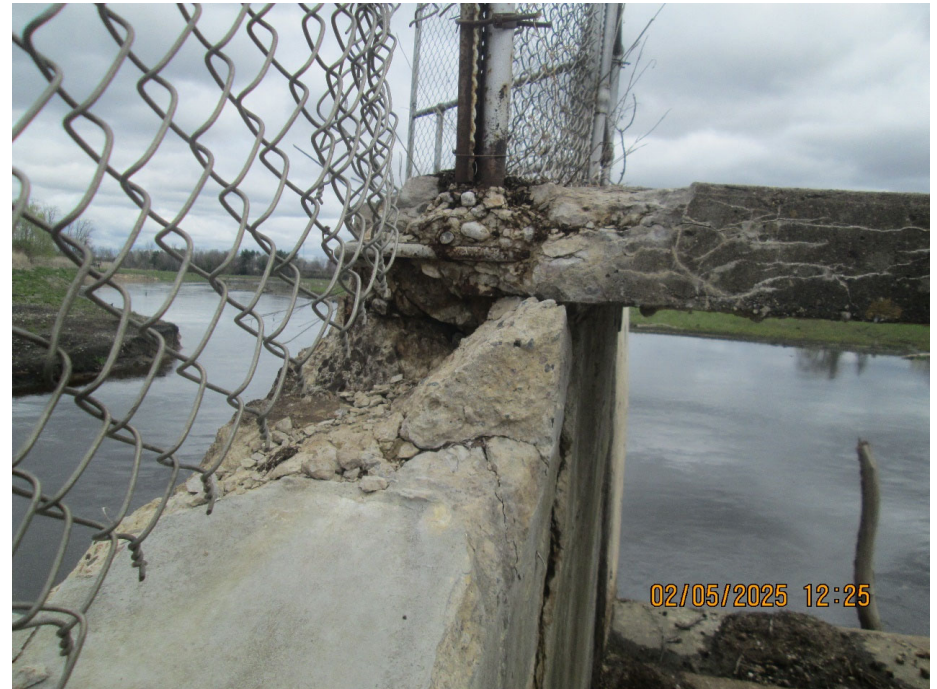
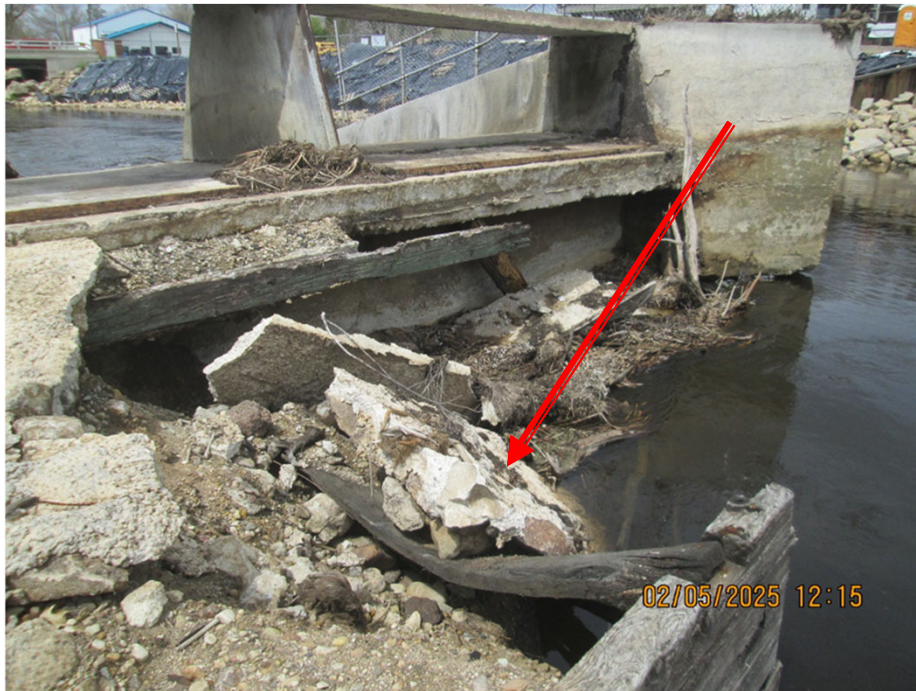
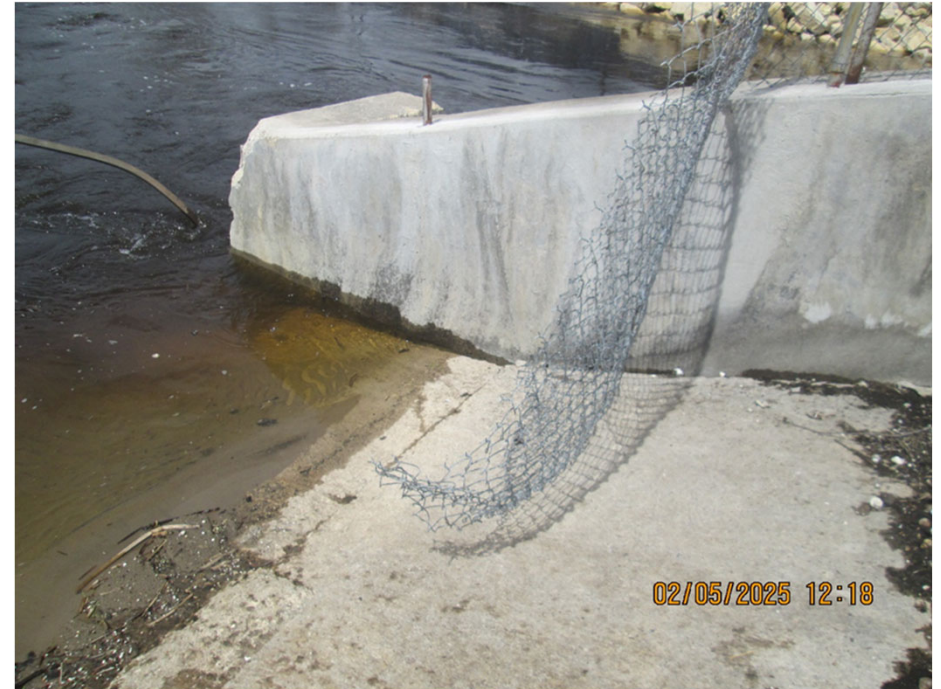
- Bay 4 and 5

- **Bay 4 and 5**
  - **Upstream portion of these bays shows major loss of material, below and behind the concrete apron**
  - **Leaking and separation between abutment and apron**
  - **The concrete walkway above these bays is noticeably sagging**
  - **There are serious cracks where the walkway meets the abutment**
  - **Downstream apron is significantly spalling and cracked throughout**

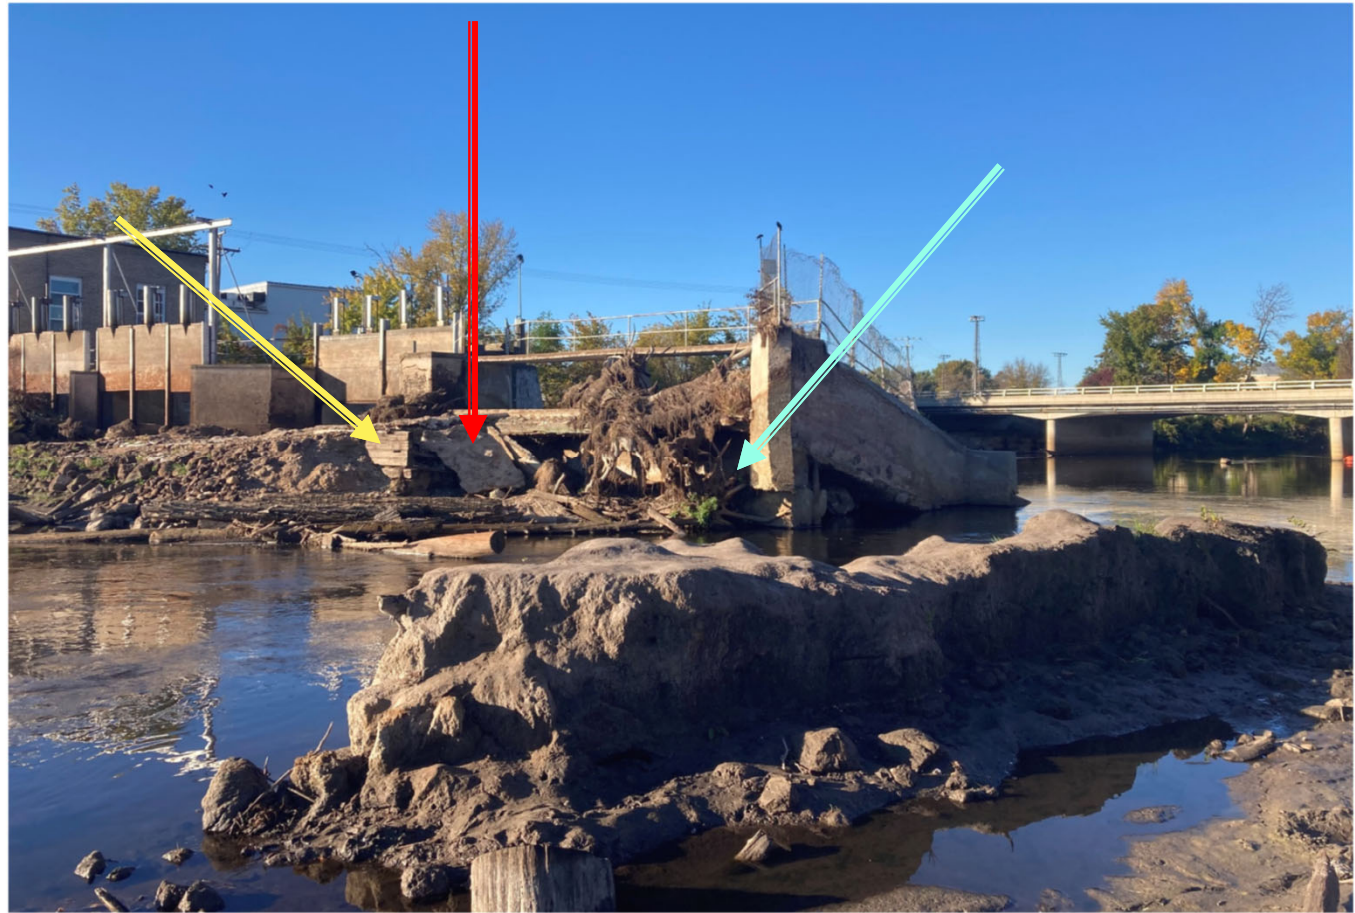
# Manawa Dam: October 2024

- **Photo shows:**
  - Pond side of the Dam
  - Timber cribbing
  - Failed grout Section
  - Undermining of concrete Dam
